## The Coombe Royal Citrus Wall

John Clark (Conservation Officer, Garden History Society SW Region) and Malcom West (Conservation Officer, DGT)

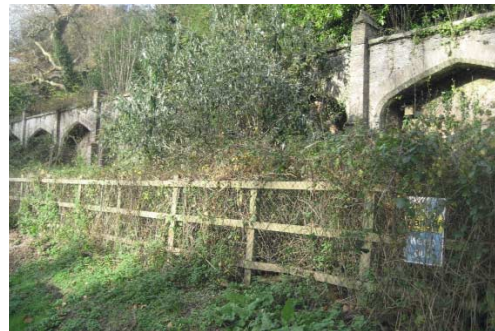
The wall and its surroundings are in need of urgent remedial works to prevent any further decay from their present 'At Risk' state, but the costs of such work are high. The vegetation around the wall, both to the front and rear, needs to be eliminated. There is excessive damp to the rear of the wall, due to the vegetation around and on the wall itself. The capping stones are badly eroded and this has resulted in the loss of the overhang intended to keep the rainwater run-off away from the wall surface. Major areas of staining and moss build-up at localised areas are especially noticeable at the rear; and spalling of the stone surface is particularly bad to the capping stones and pillar caps, some of which are entirely missing. Pointing failing allows water and plant ingress; and rusting nails and iron hooks project from the stone work.

The citrus wall today (John Clark, November, 2007)

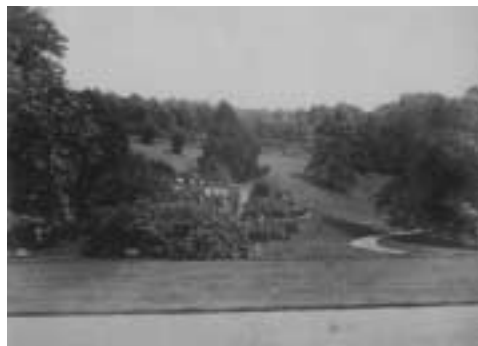
The Citrus Wall in its planned landscape context (photograph owned by Mr John Elliot)
